1. AGENCY USE ONLY (Leave blank)		2. REPORT DATE September 1996		3. REPORT TYPE AND DATES COVERED Final, April 1994 - September 1995
4. TITLE AND SUBTITLE Failure Analysis and Mechanical Tests of Failed Aluminum Alloy 7277 Rivets on Armored Vehicle Launched Bridges			5. FUNDING NUMBERS PR: 1L162618AH80

6. AUTHOR(S) Howard E. Horner				
7. PERFORMING ORGANIZATION NAME(S) AND ADDRESS(ES) U.S. Army Research Laboratory ATTN: AMSRL-WM-MA Fort Belvoir, VA 22060-5812			8. PERFORMING ORGANIZATION REPORT NUMBER ARL-TR-1195

13. ABSTRACT (Maximum 200 words) A number of the manufactured buttonheads of the 0.75-in-diameter hot-driven aluminum rivets (made of alloy 7277) were found to have fallen off Class 60 Armored Vehicle Launched Bridges (AVLB) that had been employed in Saudi Arabia during Operation Desert Storm. The presence of white corrosion deposits observed on the fractured surfaces of the failed heads indicated corrosion. The objectives of the work were to determine the cause of rivet head failures and conduct a number of mechanical tests to evaluate the integrity of the corroded rivets without their heads or with cracked heads. Corroded aluminum rivet samples were obtained, examined

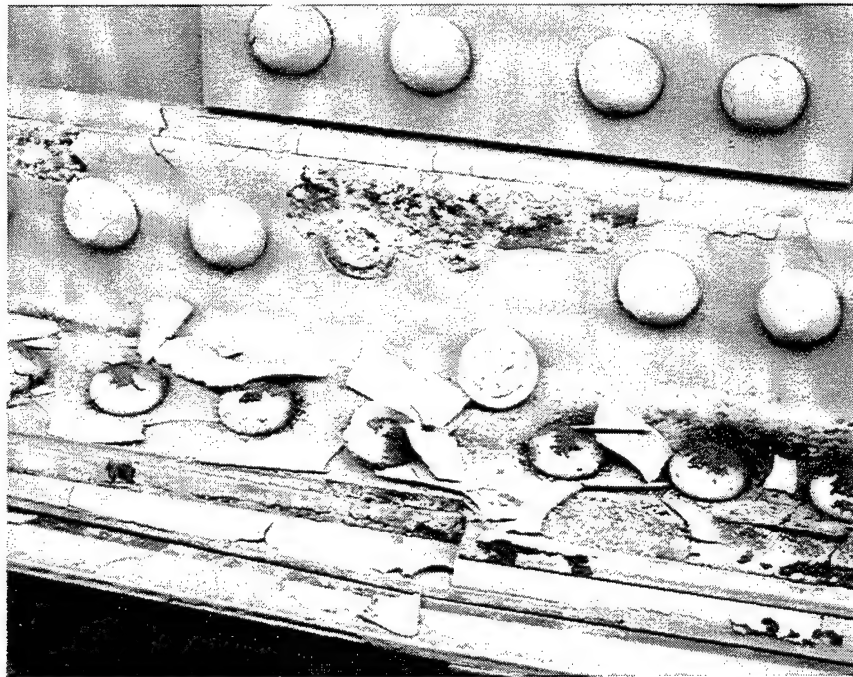
Figure 2. A view of the splice joint in the bottom chord of the AVLB from SWA, showing a failed aluminum rivet with its head already popped off. Note the white areas of the corrosion products formed on the surfaces of the fracture under the failed head as well as on the structural angle where the paint coating had flaked off.

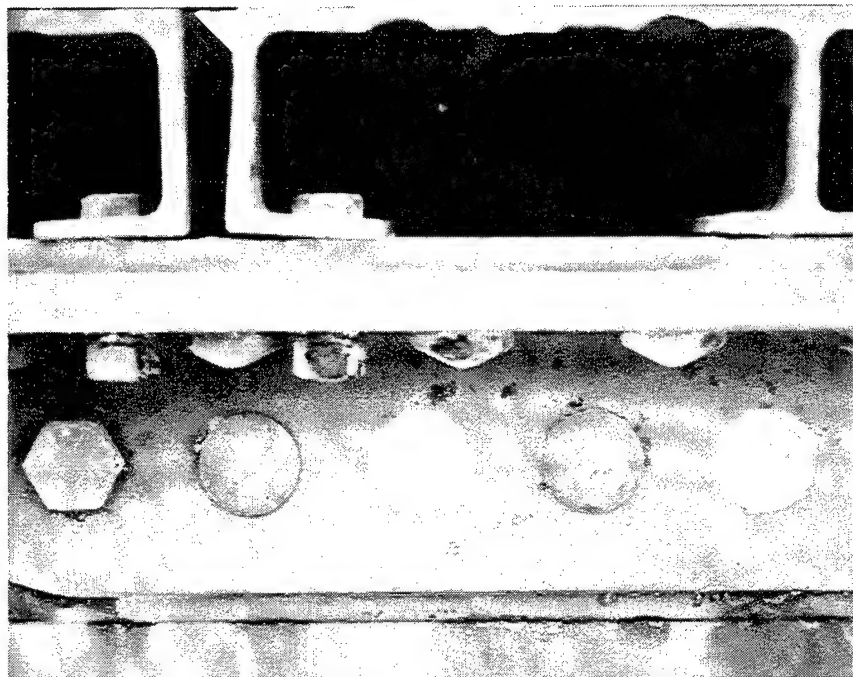
Figure 3. A view of a top chord connector of the AVL B from SWA, showing two failed aluminum rivets with their head already fallen off. The white circular areas are the corrosion products formed under the head at the shoulder and crack fracture. Note the steel bolt at far left which apparently was used to replace the rivet that failed earlier.

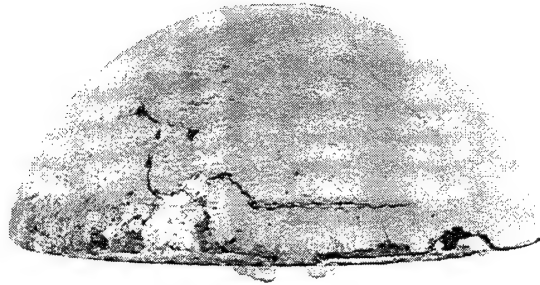
Figure 4. Side view of a failed aluminum rivet head sample received for failure analysis. The rivet shank of the failed rivet was not included for analysis. The white corrosion deposit can be seen in the area where some of the paint was chipped off the surface of the head.

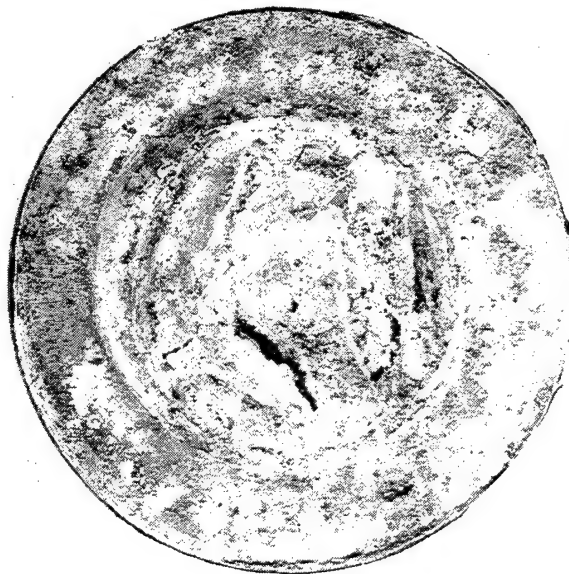
Figure 5. A view of the fracture surface of the same rivet head in Figure 4. The white areas on the fracture surface (center area) and on the head shoulder (outer rim) are the corrosion products that had formed for a period of time before the head fell off the rivet shank.

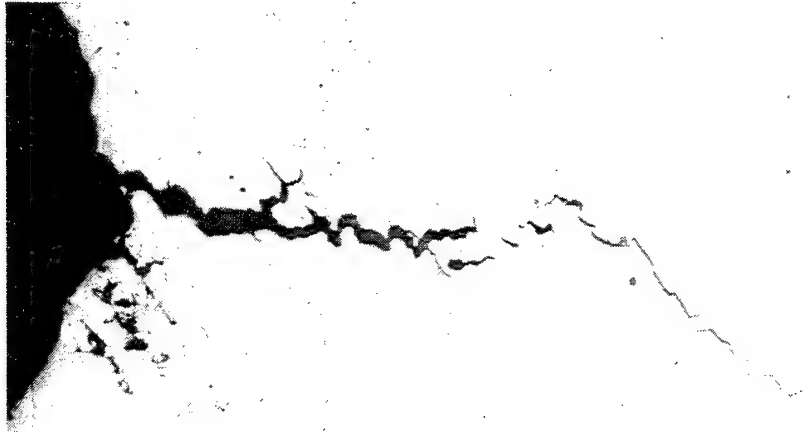
Figure 6. As-polished microstructure of the failed aluminum rivet head showing a small secondary crack in the future. Magnification: 150x.

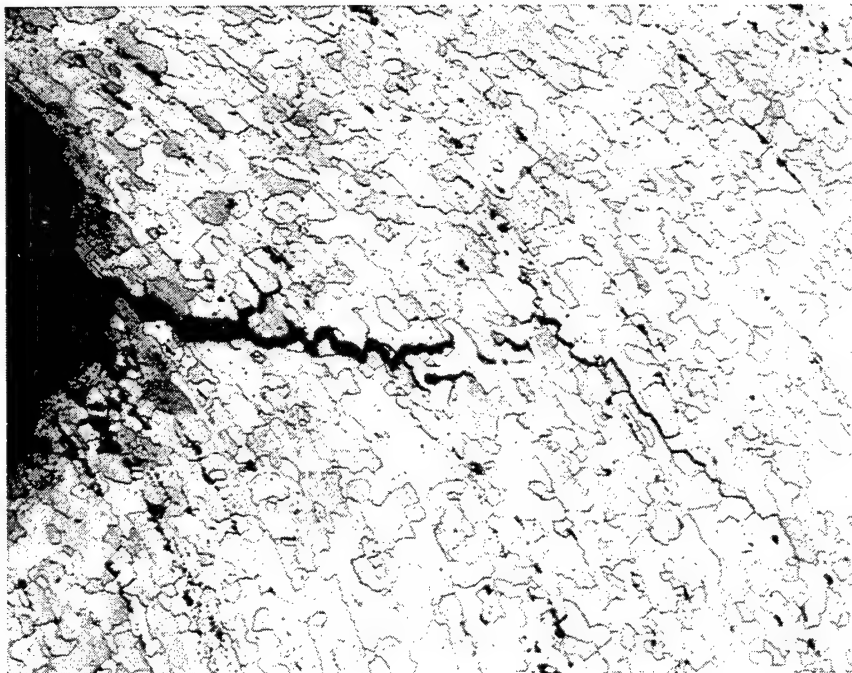
Figure 7. Etched microstructure of the same area in Figure 6 revealing that the crack is predominantly intergranular, indicative of stress corrosion cracking. The tail end of the crack had followed the grain flow formed as the result of the cold head-forming process by the rivet manufacturer. Magnification: 150x. Keller's etchant.

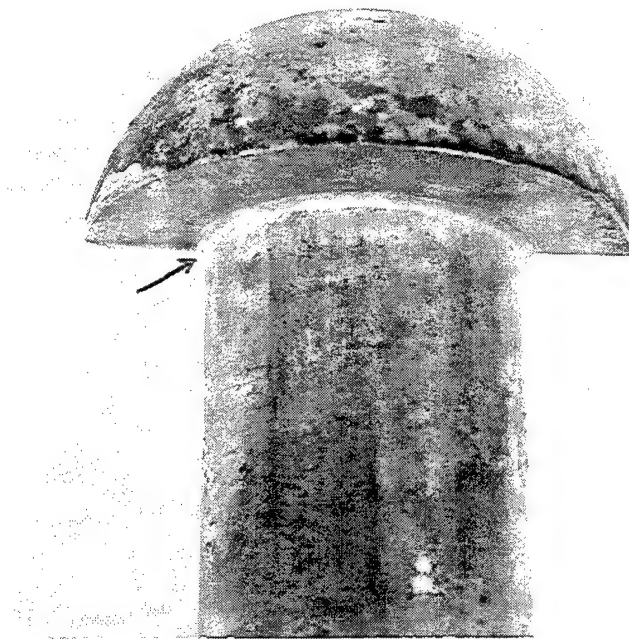
Figure 8. A view of a large aluminum rivet removed from a forged aluminum center hinge of one AVLB from SWA stored at ANAD. A small white corrosion deposit (arrow) can be seen in the head-to-shank fillet. A section of the head and shank with the corroded area was already cut off for microstructural examination. Magnification: 2 \times .

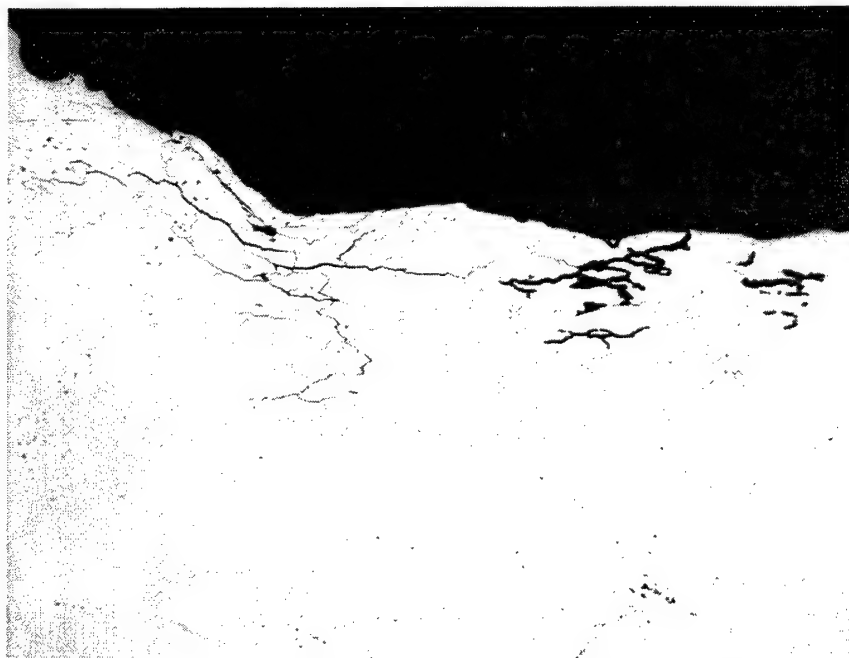
Figure 9. As-polished microstructure of the aluminum rivet in Figure 8. Intergranular corrosion and cracks are present in the small corroded area in head-to-shank fillet, indicative of stress corrosion cracking. Magnification: 170 \times .

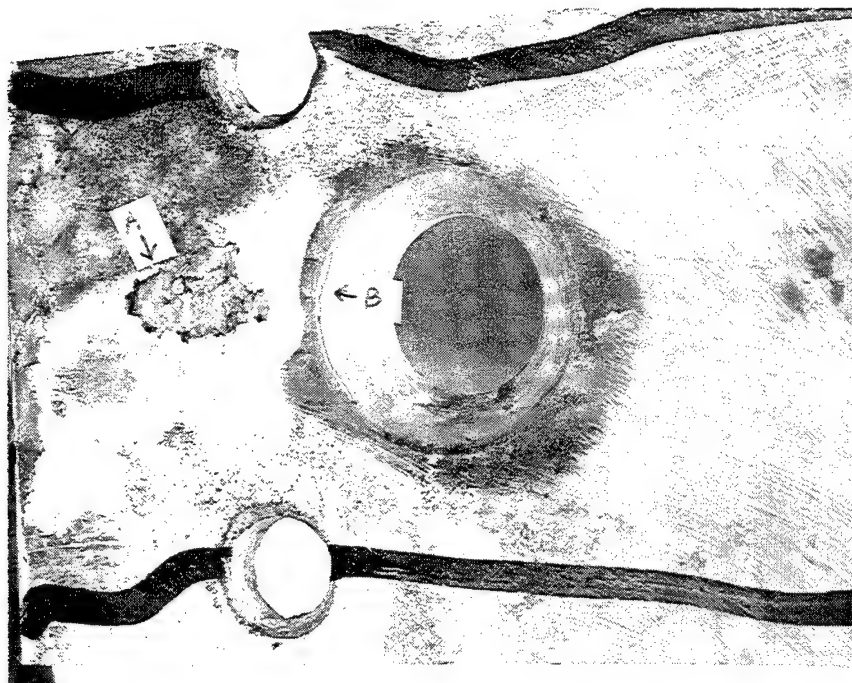
Figure 11. Large corroded hole (A) on top surface of the top chord angle section cut from AVLB center panel dismantled at ANAD. Exfoliation had extended laterally beyond the hole of the corroded area. Delaminated surface crack (B) due to exfoliation was observed near the top of the large countersunk rivet hole. Slightly larger than actual size.

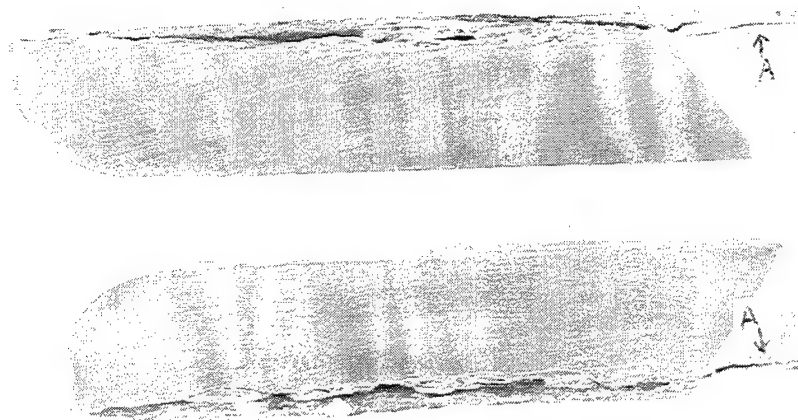
Figure 12. Matched half sections of the corroded sample in Figure 11. It was cut in two through the large corroded hole. Delaminated surface cracks (A) were observed in the countersunk section of the rivet hole on the right, revealing extensive exfoliation beyond the corroded hole. Magnification: approximately 2x.

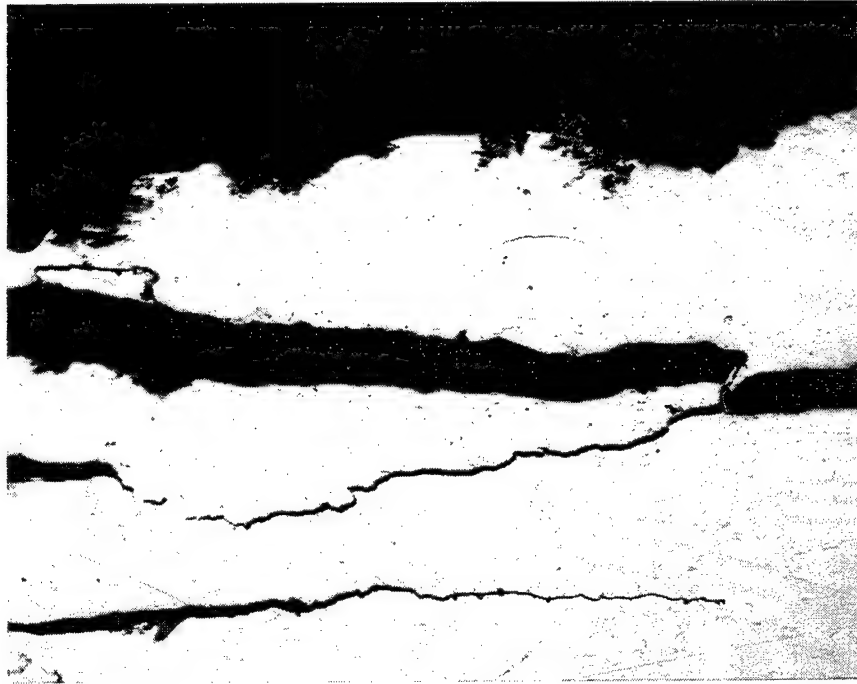
Figure 13. As-polished microstructure at the bottom of the corroded hole in Figure 11. Exfoliation was the primary mode of corrosion on the corroded surface of the angle section of the AVLB top chord. Magnification: 75 \times .

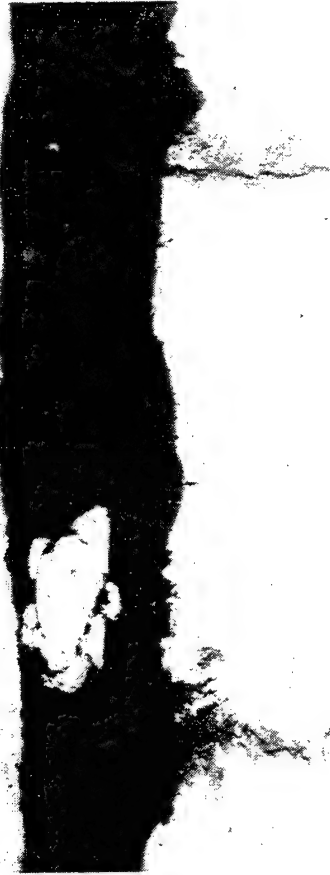
Figure 16. As-polished microstructure of the rivet shank (right) and space bar at the interface in the rivet hole of the bar in Figure 15. Small corrosion pitting had occurred on the shank surface of the rivet in the rivet hole of the bar, resulting in small cracks initiating from the bottom of the pits. Magnification: 190 \times .

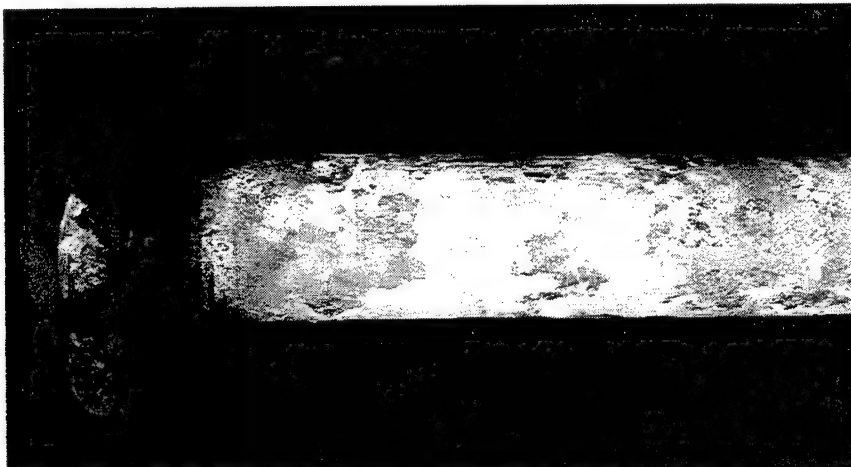
Figure 17. A 4-in-long large aluminum rivet sample with heavy deposits of white corrosion products on the surface of its shank. The driven end of the rivet is on left. Slightly larger than actual size.

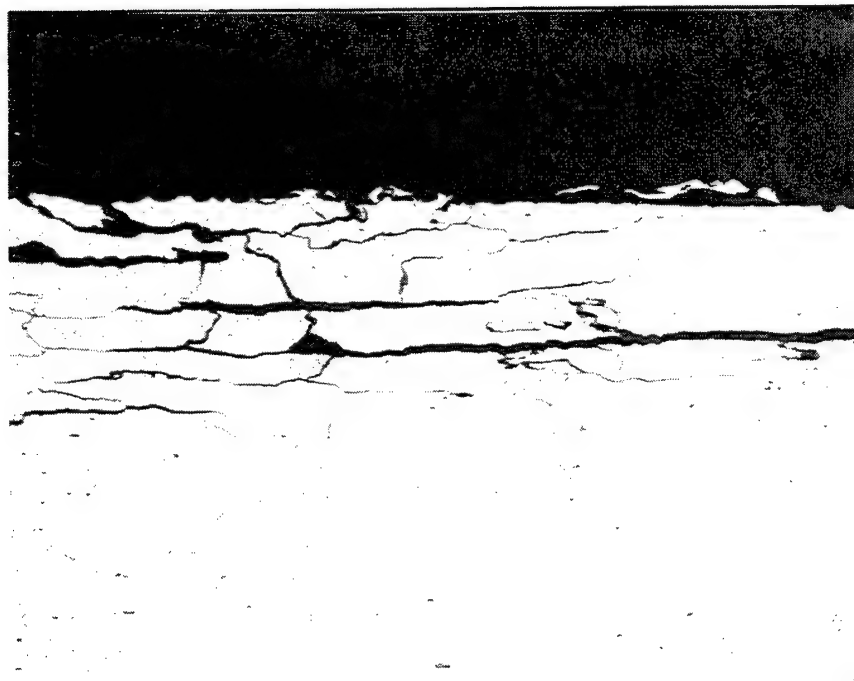
Figure 18. As-polished microstructure of a small corroded area on the surface of the rivet shank in Figure 17 covered with thick corrosion products. Integranular corrosion and cracks (SCC) were observed at the corroded surface. Magnification: 100 \times .

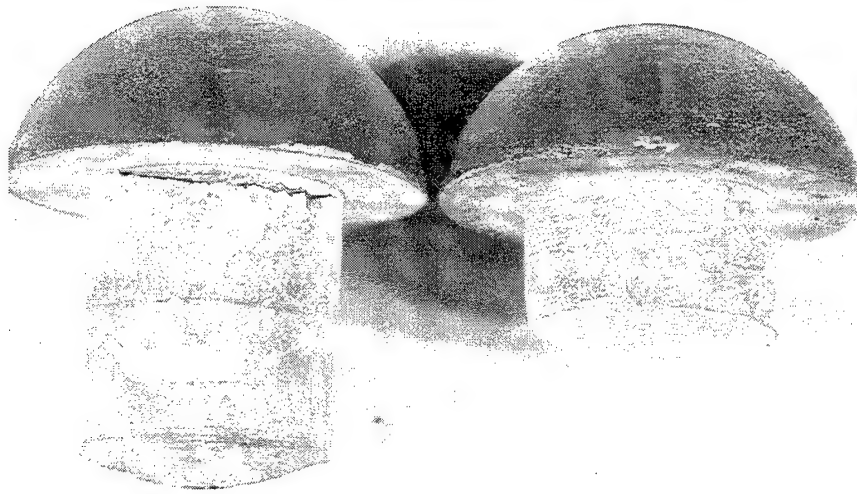
Figure 23. View of "Bad" (left) and "Good" rivets after the shear tests. A large crack is seen in the head-to-shank fillet of the "Bad" rivet. White corrosion products were on the surface of the rivet shank of both rivets. Magnification: approximately 1.33x.

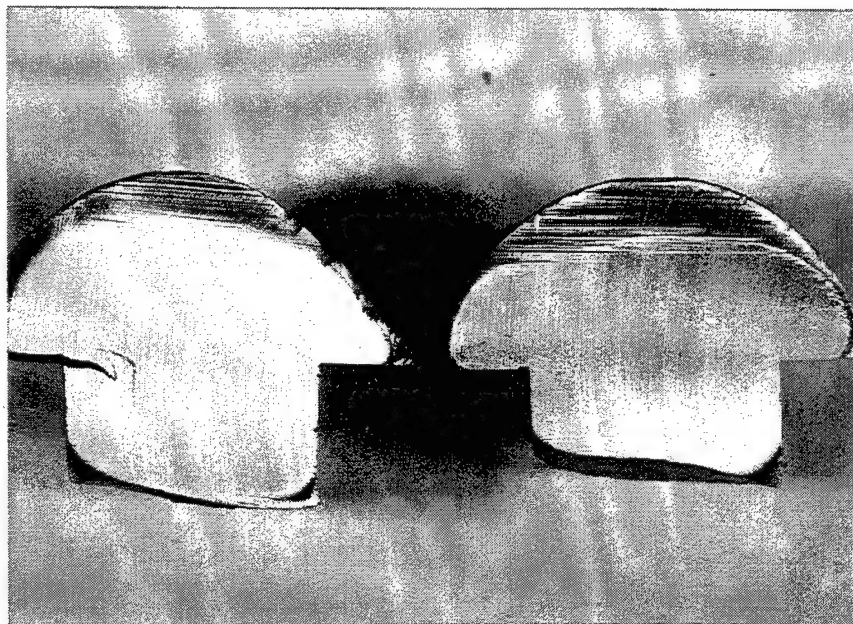
Figure 24. Cross sections of AVL B corroded rivet heads sectioned in two after the shear tests. The "Bad" rivet with large and small cracks in the left fillet under the head on the left. The "Good" rivet on right did not have observable cracks. Magnification: approximately 1.33x. Grit 600 surface finish.

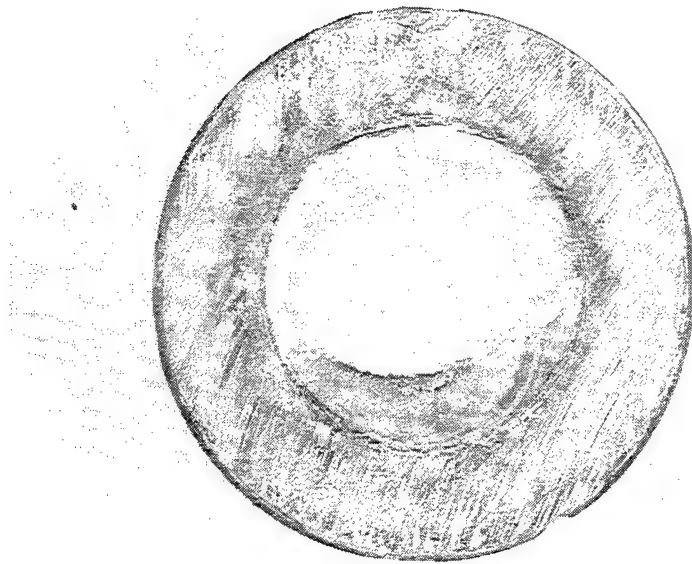
Figure 29. Enlarged view of the fracture surface of the rivet head (specimen C) that broke at the head-to-shoulder fillet after the pull test, revealing the darkened area of the crack because of corrosion (stress corrosion cracking).

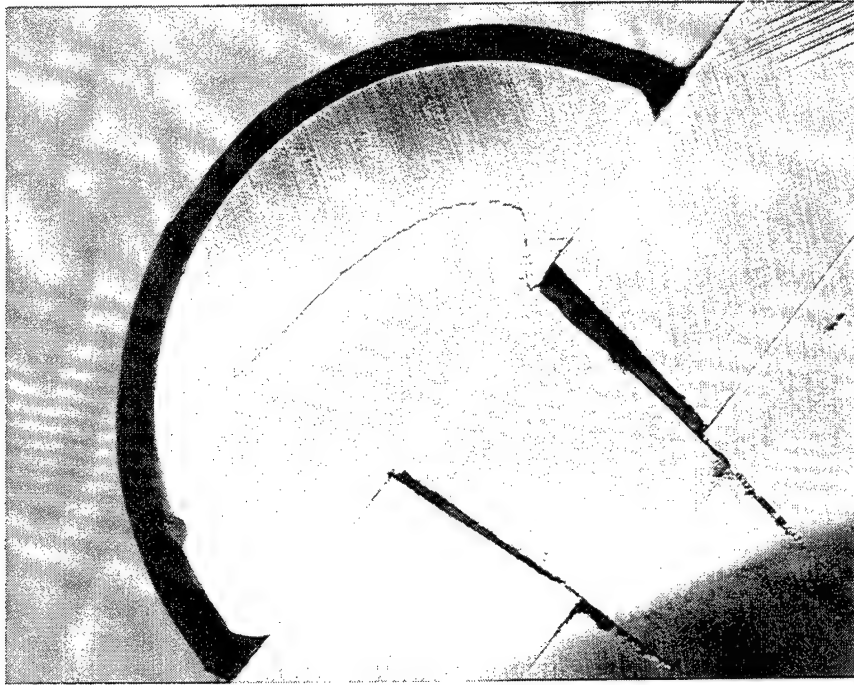
Figure 31. A view of the cross section of the installed rivet showing a large crack in the head. The crack initiated in the fillet. Magnification: 3 \times . As-polished.

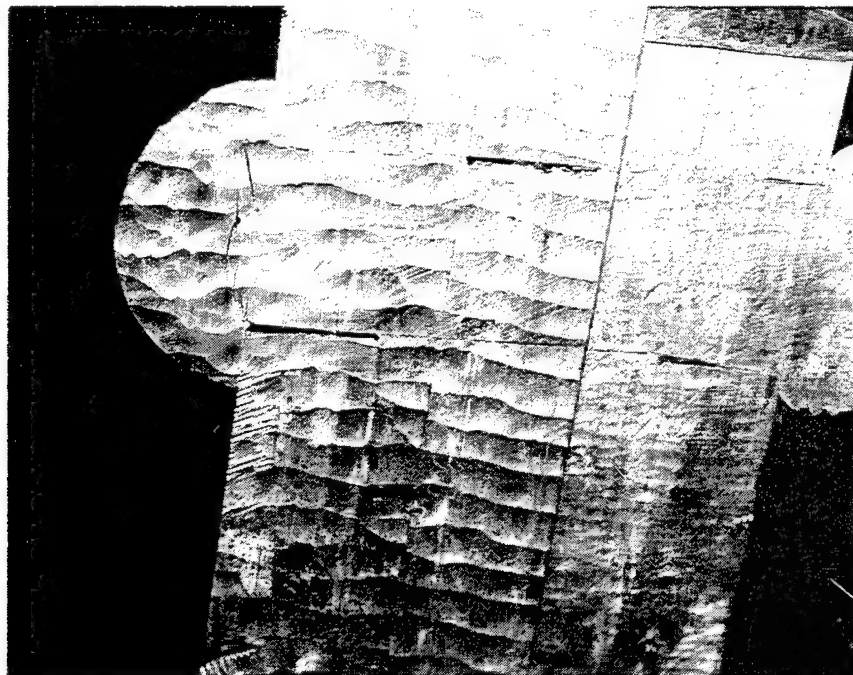
Figure 32. A view of the rivet that was rough cut in half lengthwise in the top connector of the AVL B, thus revealing large cracks in the head. The crack initiated in the fillet. See Figure 33 for polished surface of the same rivet.

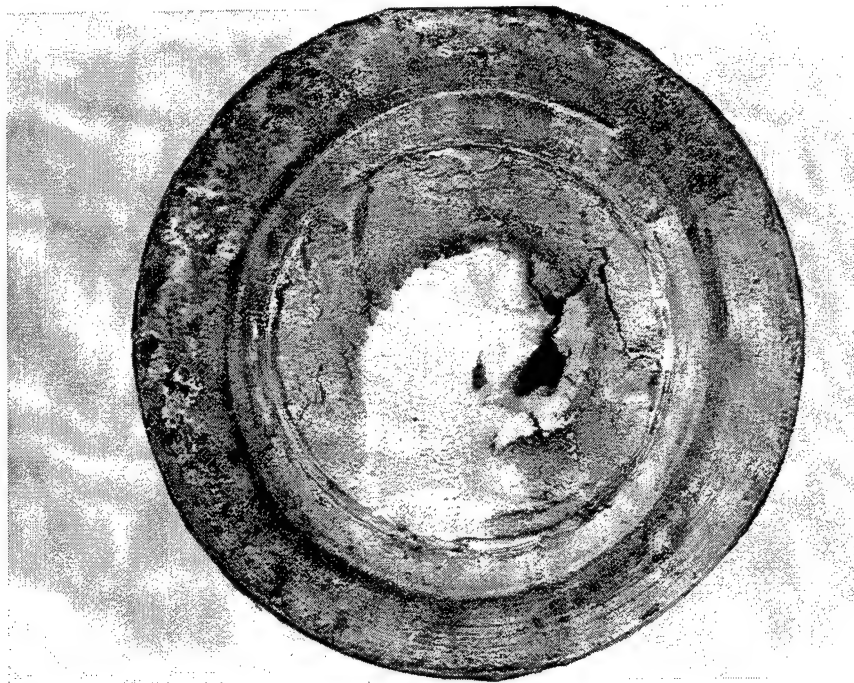
Figure 36. Enlarged view of the fracture surface under the head of specimen C "Bad" rivet after the pull test. The crack (discolored area because of corrosion) covers about 65% of the shank cross section, hence the reason for the low breaking load recorded during test. Magnification: approximately 3x.

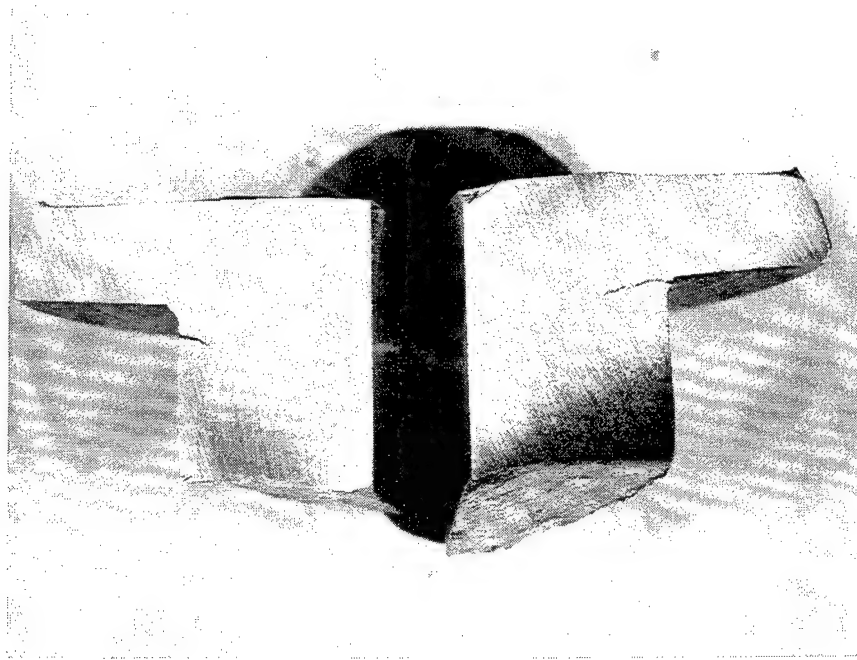
Figure 37. Enlarged view of two quarter sections of specimen D "Bad" rivet in Figure 34. Large cracks can be seen to initiate in the fillet of the right section and in the shank near the fillet of the left section. The crack on right is about 0.140-in deep. Magnification: 3×. Surface finish: Grit 600.

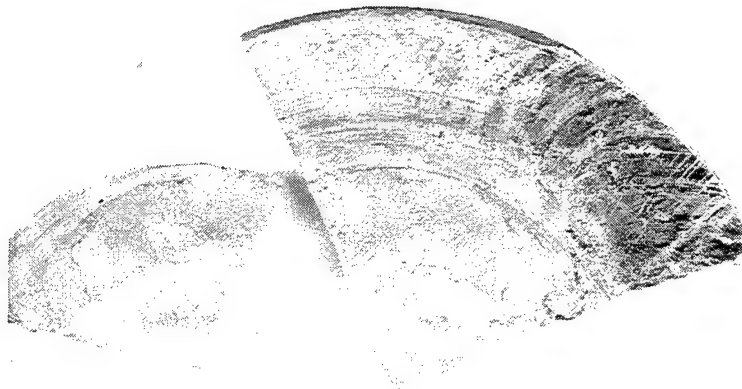
Figure 38. Matched cross sections of the right quarter section in Figure 37. This section was deliberately broken apart at the crack in the fillet to reveal the extent of the crack (discolored area) in the fracture surface.

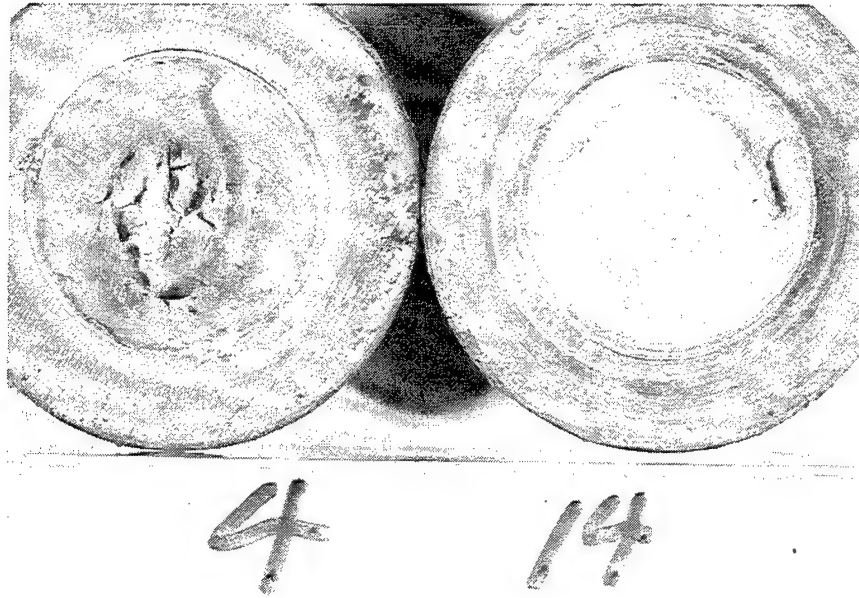
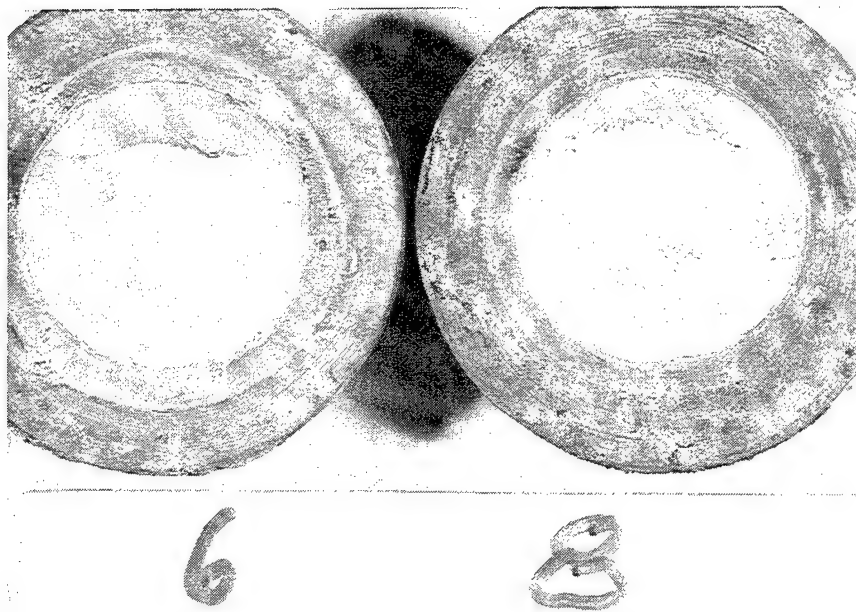
Figure 40. Enlarged views of the fracture surface under the buttonhead of four rivet samples after the pull tests revealing the extent of cracks (darkened area) observed due to corrosion. Sample 4 (95.37%), no. 14 (26.95%), no. 6 (19.62%), and no. 8 (11.60%).

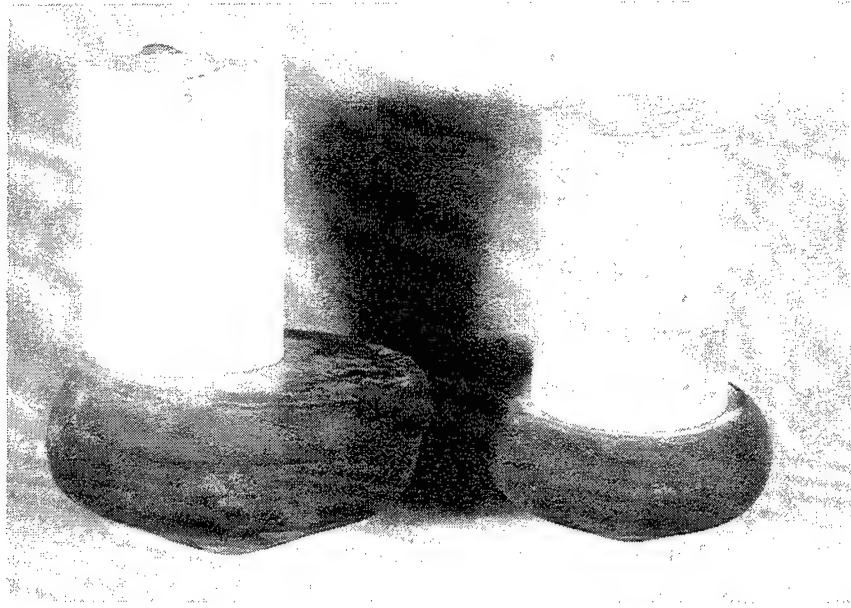
Figure 42. A view of the headless AVL B aluminum rivet samples 10 (left) and 15 after the plunger push tests, revealing the condition of the corroded rivet shanks. A load of 9,880 lb was required to push sample 10 out of the rivet holes as compared to 260 lb for sample 15. Note the complete coverage of thick white corrosion products on the shank surface of sample 10 vs. small corrosion pittings on sample 15. Also, note the larger size, off-center driven end of sample 10 as compared to the normal, centered end 15. This was due to use of incorrect, longer length rivet (sample 10), which probably allowed moisture to enter into the rivet hole at the very narrow flange (left side of sample 10) of the driven end, resulting in extensive formation of corrosion on the rivet shank surface. Magnification: 1.33x.

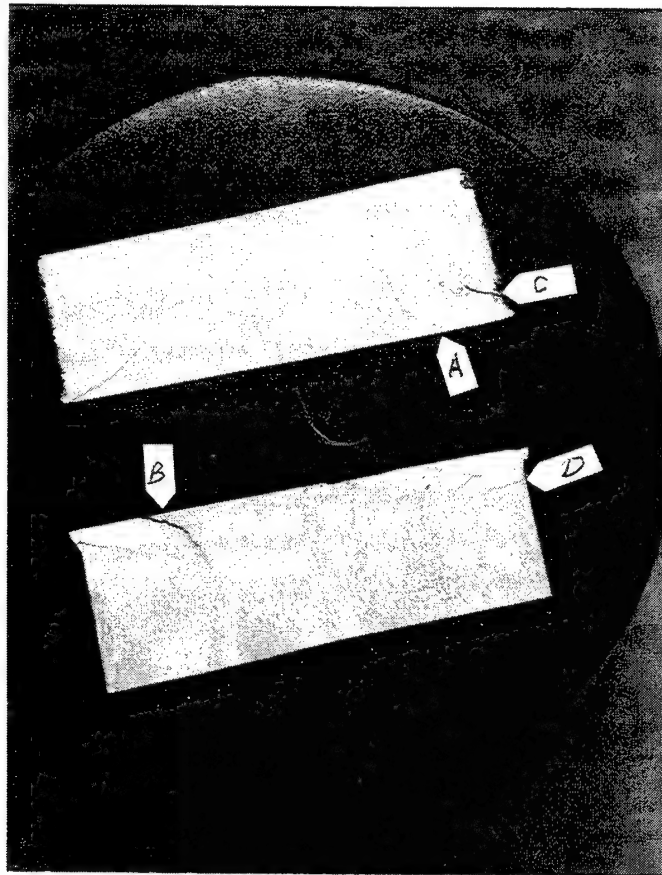
Figure 43. Enlarged view of the etched cross sections of the corroded AVL B rivet samples 10 (top) and 15, revealing stress corrosion cracks (dark curved lines) in the headless ends (arrows A and B) where the rivet buttonheads were sawed off. Most cracks observed were initiated at or near the fillets (partly seen in the photograph) and followed the grain flow caused by the head-forming operation. The microstructure at arrow C is seen in Figures 44 and 45, and that at arrow D in Figures 46 and 47. Magnification: 3.17x. Keller's etchant.

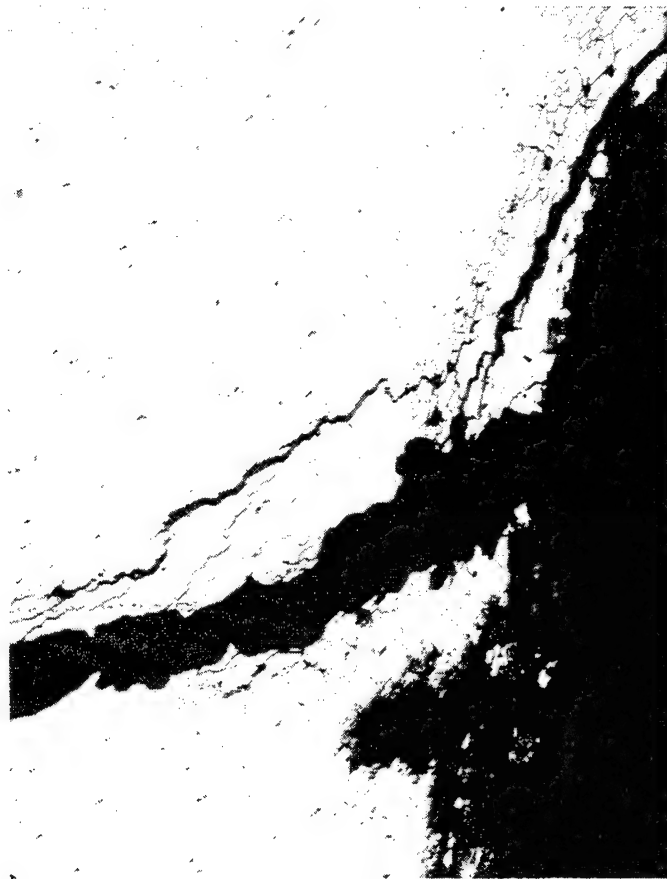
Figure 44. As-polished microstructure of stress corrosion cracks on the shank of corroded rivet sample 10 near the fillet. Note the intergranular corrosion on the surface of the shank (right side) and in the major cracks. Magnification: 100×.

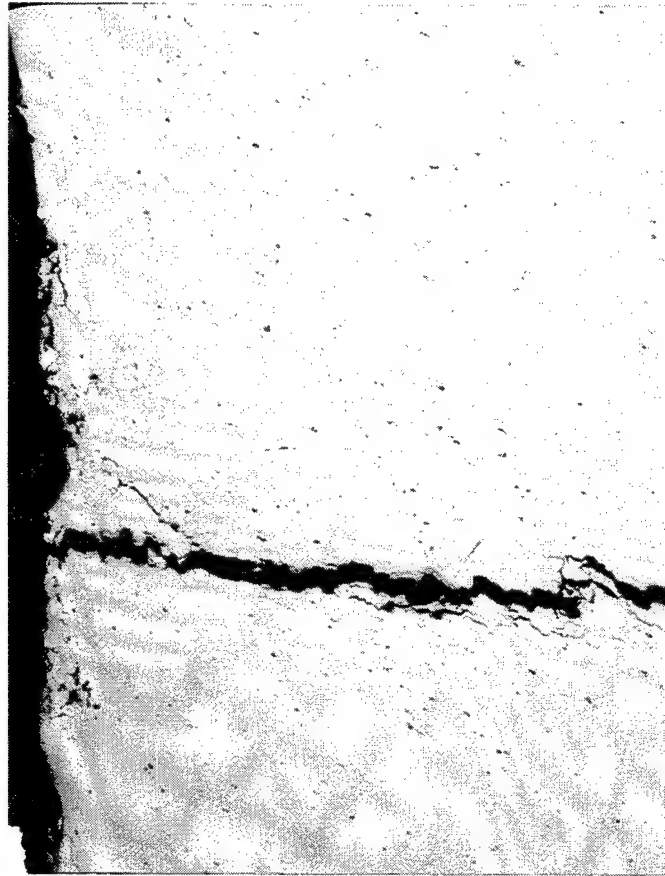
Figure 46. As-polished microstructure of stress corrosion cracks on the shank of the corroded sample 15 near the fillet area. Note the intergranular corrosion (not clearly seen in this photograph) on the surface of the shank (left side) and in the major crack. Magnification: 100x.

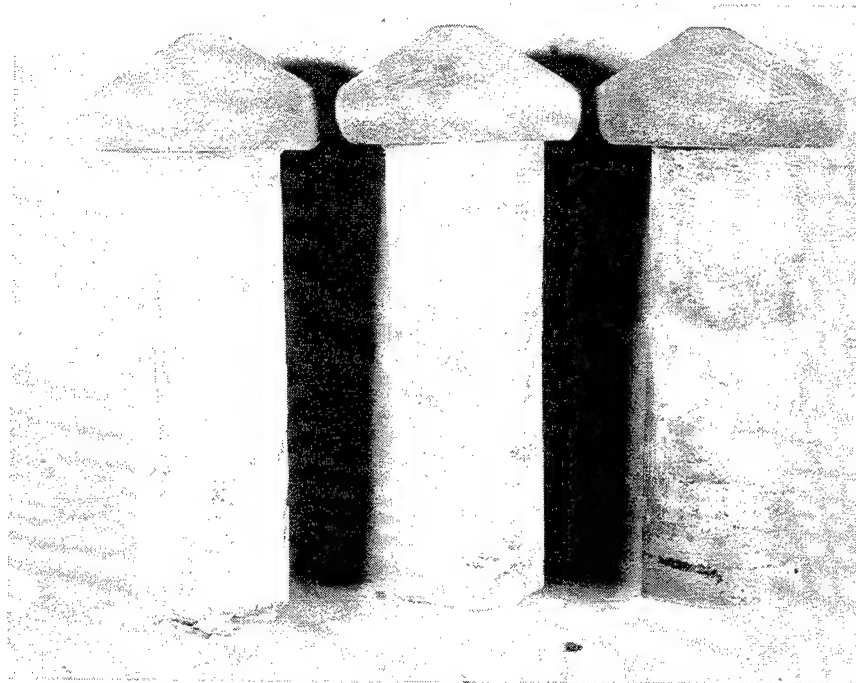
Figure 51. A view of the white corrosion products on the surface of the shank of the no. 1 headless corroded rivet at left, no. 5 rivet in middle, and no. 7 rivet at right. The loads required to break the rivets loose in their rivet holes were 19,000 lb for no. 1; 1,500 lb for no. 5; and 500 lb for no. 7.

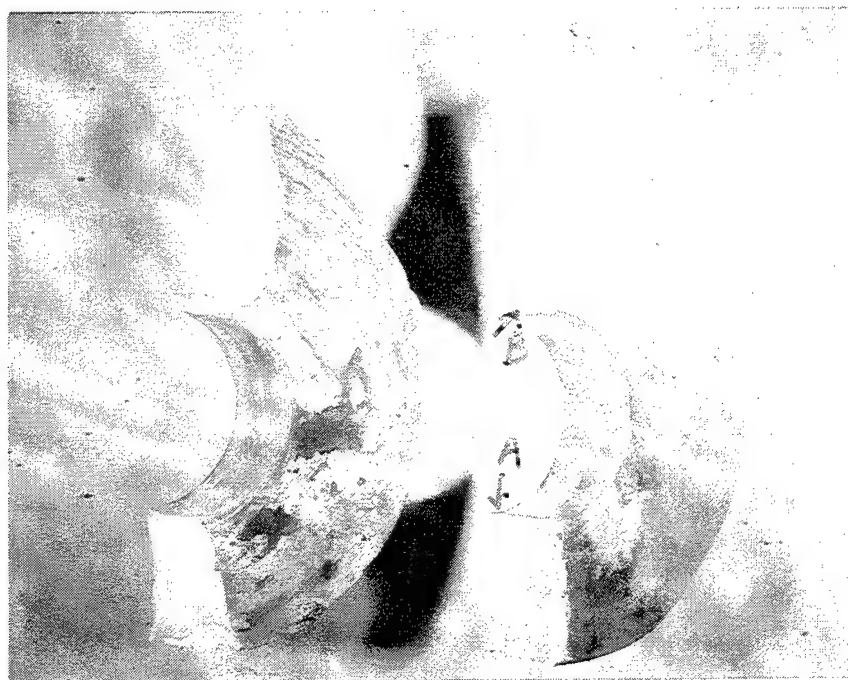
Figure 52. View of broken inboard female center hinge eyes. The piece on left is part of the inner hinge forging, and the other piece is part of the outer hinge forging that broke first at 95-ton load. Small fatigue cracks at A and B are seen in Figures 55 and 56.

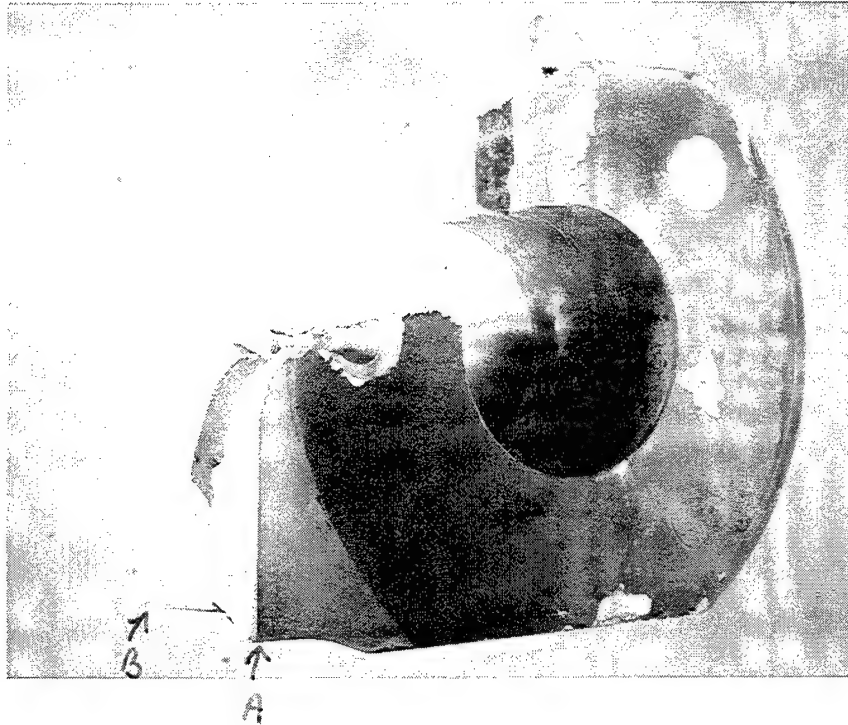
Figure 53. View of broken outboard bottom chord male connector eyes from the female center panel assembly after the failure test. The brittle fractures initiated at A and B because of the sharp machined fillets (straight edges). Closeup views of small fatigue cracks at A and B are seen in Figures 57 and 58.

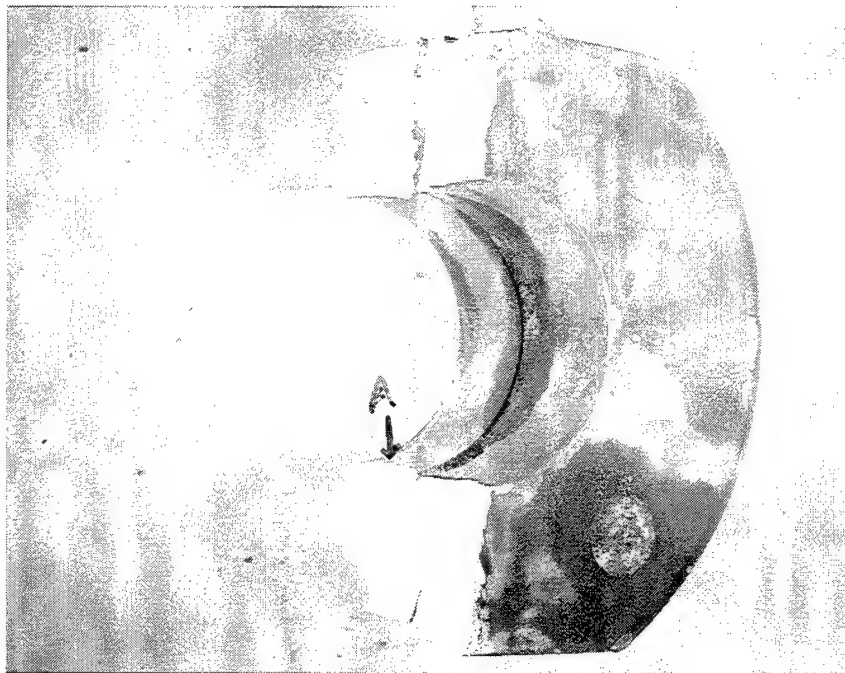
Figure 54. View of broken inboard bottom chord male connector eyes from the female center panel assembly. See Figure 59 for closeup view of the crack initiation site at A.

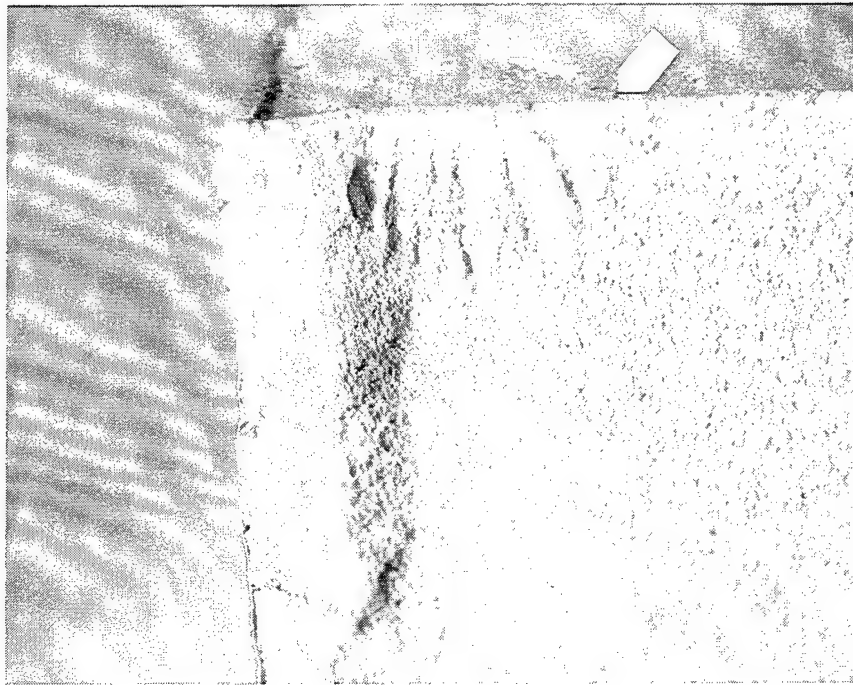
Figure 55. Closeup view of a small fatigue crack (arrow) at A in Figure 52. This eye piece of the forged female center hinge broke first at 95-ton load, initiating at this fatigue crack.

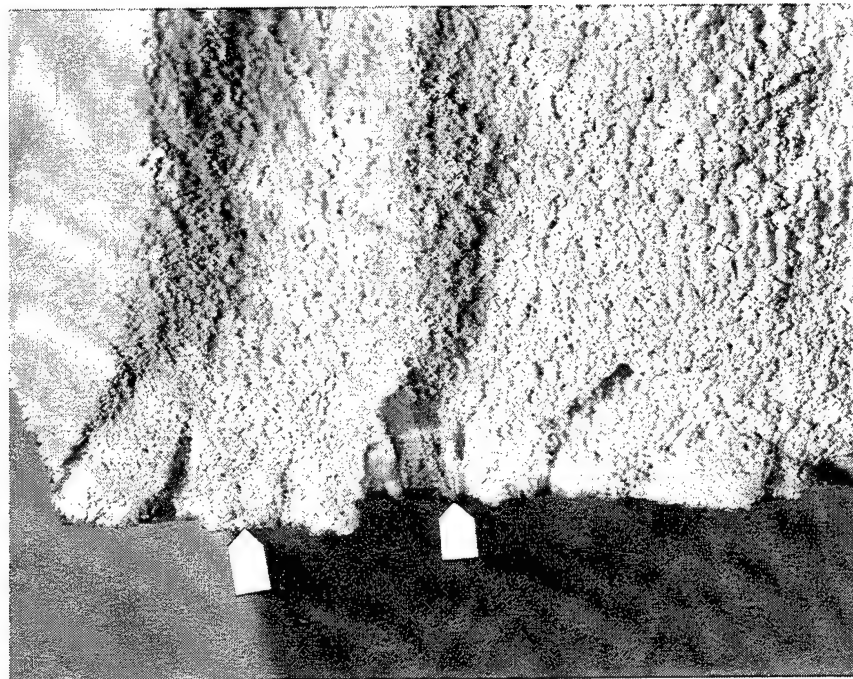
Figure 56. Closeup view of small fatigue crack (top edge) at B in Figure 52 after the eye piece broke from the forged female center hinge at 115-ton load.
